CAPITAL RESERVE STUDY

Sample Association

March 26th, 2015

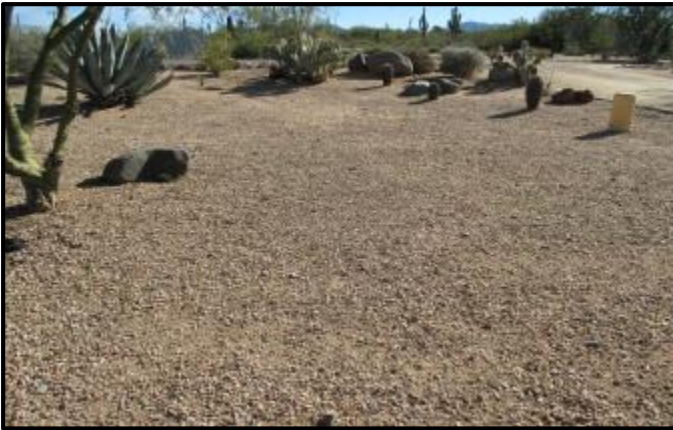
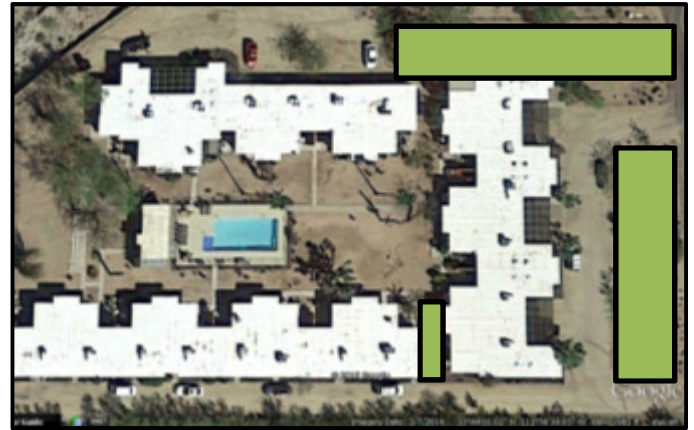
Over time, with rains, irrigation, silting, and being tread upon, granite is ground into smaller pieces and loses its fullness. To avoid exposed patches of dirt, we recommend periodic top dressing of the landscape rock. There is approximately 8,400 square feet of landscape rock located throughout the property. This component budgets to replenish 100% of the total square footage with ¾" rock at 2" deep which converts to approximately 70 tons of rock. Recommend replenishment at roughly the timing and costs above. See image above for areas currently covered with Landscape Granite. **Note:** We are only budgeting to replenish the areas highlighted in green above.

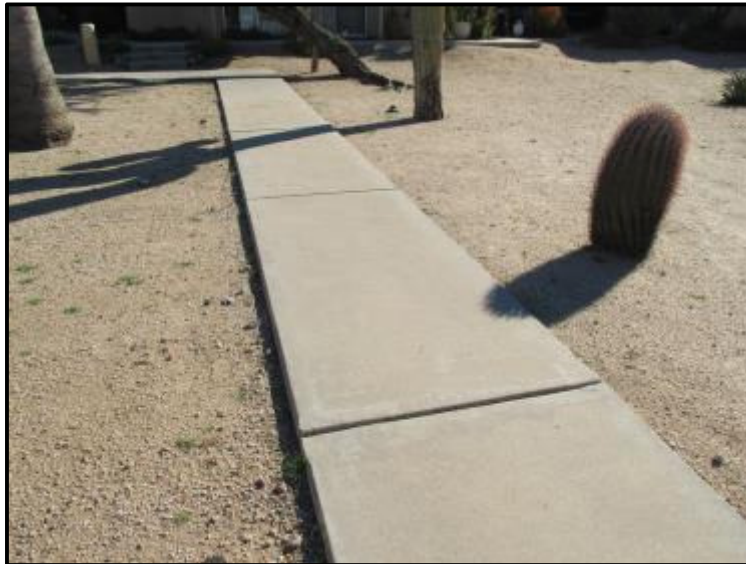
Concrete - Repairs

The association maintains approximately 1,370 square feet of concrete sidewalks and surface area throughout the property. These sidewalks are in overall good condition. Some signs of minor deterioration and cracking noted, however nothing major. Concrete surfaces typically have a useful life of up to 65 years although partial failures and deterioration is common. Weather conditions, installation methods and finishing techniques can result in premature deterioration such as cracks, chips and spalls. Various conditions like these result in the need to plan for periodic partial replacements over the next 30 years. We estimate approximately 10% of the concrete surfaces will require replacement on a 10 year cycle.

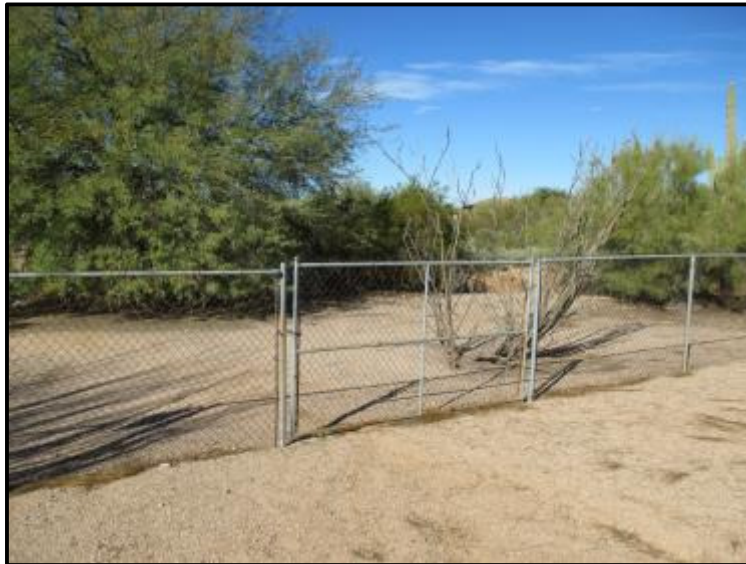
Chain Link Fence – Replace

There is approximately 165 linear feet of 5' high chain link fencing located along the West perimeter of the property. This fence appears original from the 1970's. The association plans to replace this fencing with new wrought iron fencing to match the rest of the property fencing. Metal fencing has a long useful life, but is not maintenance free. Periodic maintenance should include periodic applications of protective paint finish. We anticipate a useful life of up to 30 years for this fence.

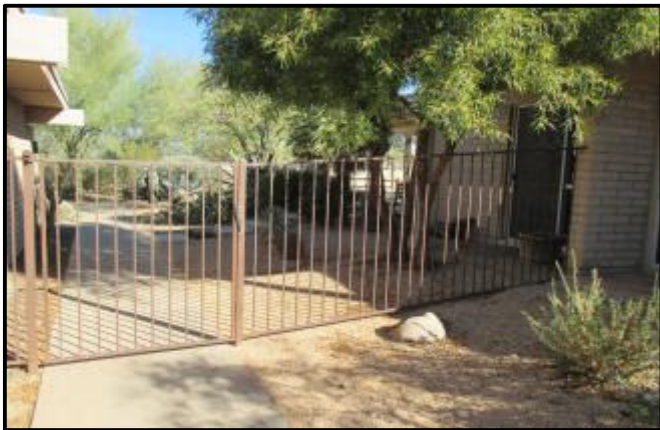
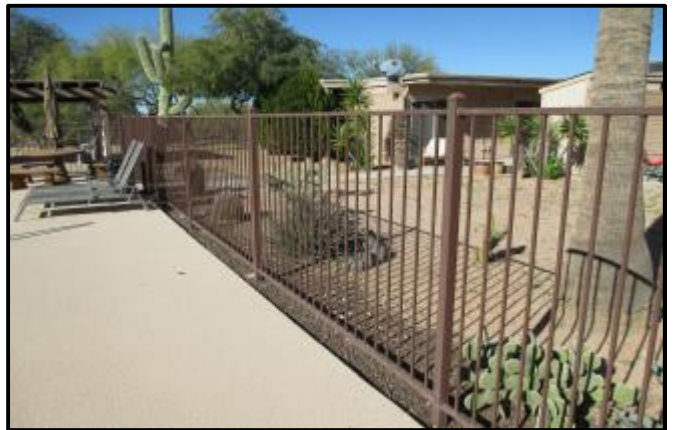
Pool Fence - Replace

This component includes 190 linear feet of metal pool fence and 30 linear feet of fencing and gates located on the north and south side of the property. Repainting should be handled as an Operating expense; therefore no Reserve Funding is required. Metal components and structural connections are prone to rusting if not thoroughly maintained.

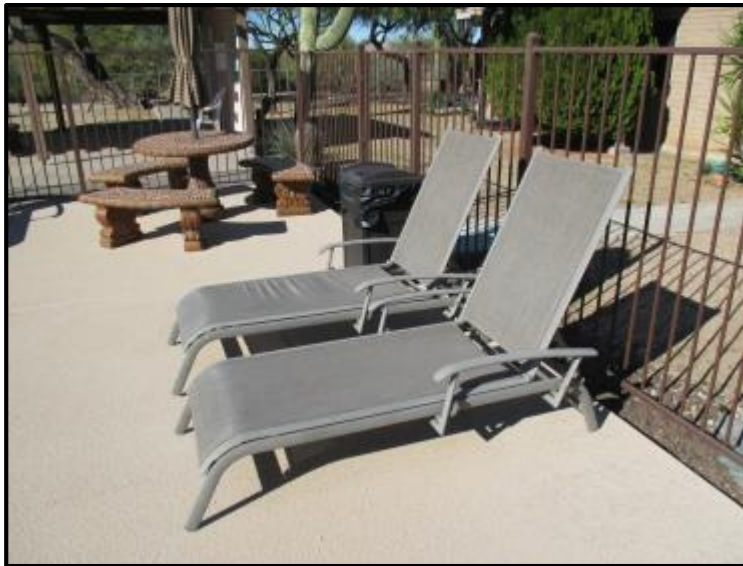
Pool Furniture - Replace

Furniture installed during 2011. This component includes (6) chaise lounges, (2) trash receptacles, (5) table chairs, and (2) fabric umbrellas. We are not funding to replace the (3) concrete tables as these should last the lifetime of the property. See the table below for unit costs and quantities.

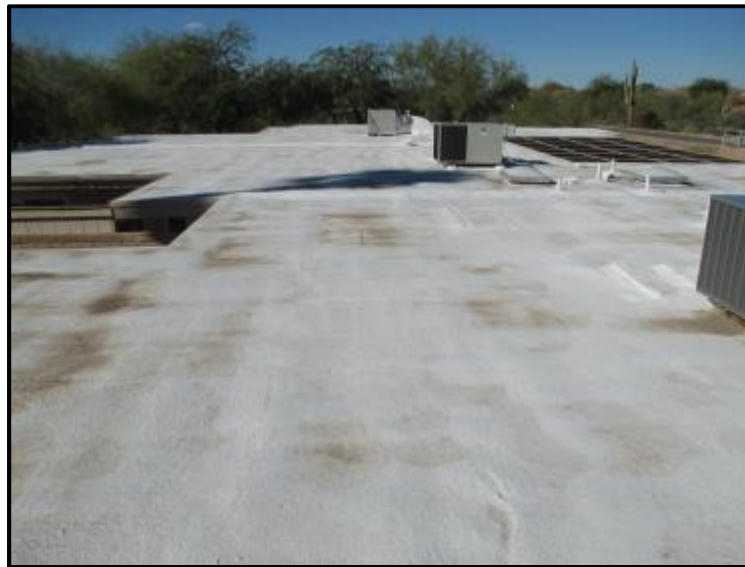
The North and South foam roofs were recoated during 2011. During our inspection, we noted signs of ponding and some areas of minor damage. Recommend inspecting regularly and removing debris. If water sits on the surface for more than 48 hours, it is called ponding. Ponding breaks down the acrylic coating and reduces the service life of your roof. Per **Sprayfoam Southwest**, foam roofs should be recoated 10 years after installation and every 5 years thereafter. If properly maintained, these roofs will last the lifetime of the community. Recommend annual inspections and repairs when needed.

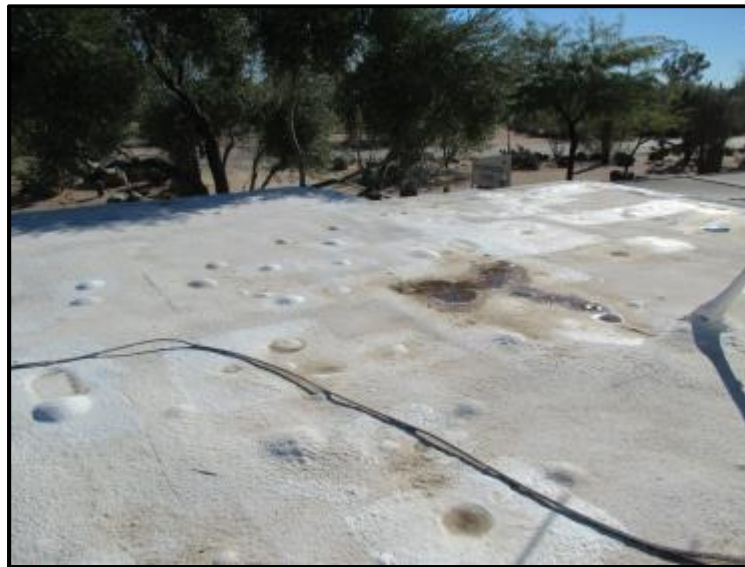
The East foam roof was replaced during 2011. During our inspection, we noted signs of ponding and several “Blisters”. When moisture gets trapped while foam is being applied, it can cause high spots, or “blisters” in the foam. If the blister is sound enough structurally and is not broken, it is a cosmetic issue, unless it is creating severe ponding. If it is creating severe ponding, the acrylic can lift or separate from the foam, which will require maintenance more often than the rest of the roof. If the blister is broken, it can cause seepage into and below it. If “Blisters” get broken, they need to be cut it out and foam and acrylic coating need to be re-applied. Recommend inspecting regularly and removing and debris. Per **Sprayfoam Southwest**, foam roofs should be recoated 10 years after installation and every 5 years thereafter. If properly maintained, these roofs will last the lifetime of the community. Recommend annual inspections and repairs when needed. The remaining useful life of 6 years represents the 10 year initial warranty.
