Sample High-Rise Owners Association

Regarding: Fiscal Year beginning 1/1/2017 - Level I Capital Replacement Reserve Study

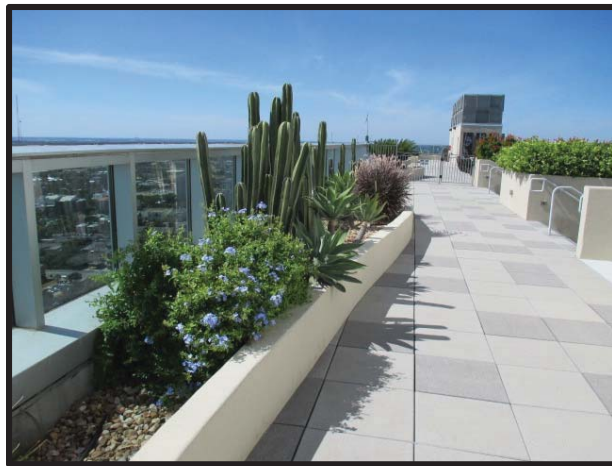
Age: Using 2010 as the average install date.

Current Condition: No reported leaks or issues.

Planter interiors need to be emptied and waterproofed periodically to prevent water from penetrating the structure of the planter and comprising any surrounding structures (decking, buildings, etc.) Typical project includes waterproofing of all interior surfaces (sides and bottoms) in contact with plants/soil/water. Costs can vary greatly depending on quantity, orientation and location of planters, as well as costs to re-plant and repair/replace any damaged irrigation components. Should ideally be coordinated with any other decking/waterproofing projects, such as balconies or pool decks.

Maintenance Requirements: Inspect regularly and repair as-needed.

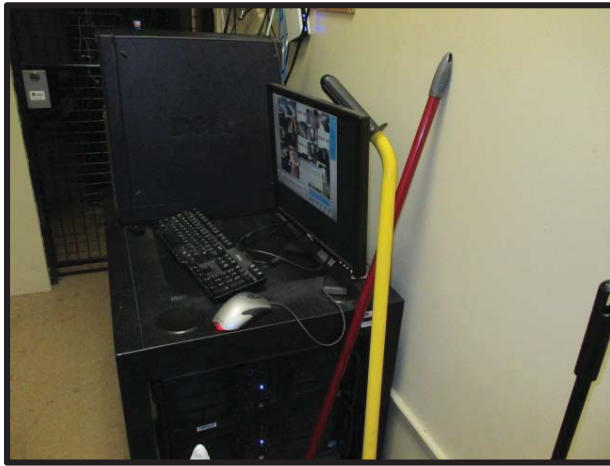
Surveillance System - Replace

Age: Installed during 2013.

Current Condition: System is new and in good working order.

Maintenance Requirements: Replace individual components as an Operating expense.

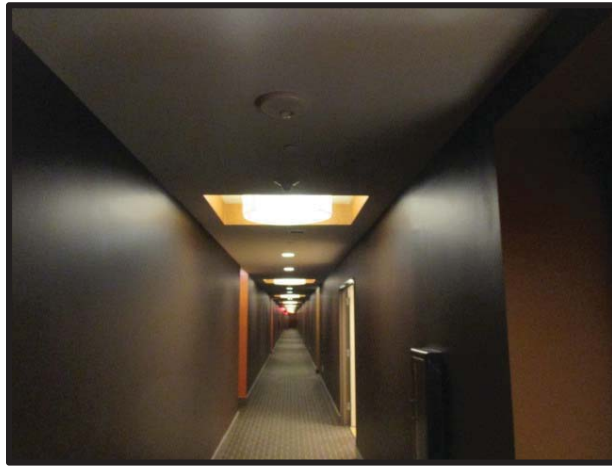
Wallcovering - Replace (Levels 25-33)

Age: Using 2010 as the average install date.

Current Condition: No signs of rips, tears or peeling.

Wallcoverings should be replaced eventually to update appearance of common/amenity areas. Best practice is to coordinate at same time as other interior projects whenever possible to minimize downtime and maintain consistent quality standard. Timing and interval is subjective. Estimates shown here are based on our experience with similar properties and general aesthetic qualities. Schedule can be updated/adjusted at the discretion of the association for planning purposes.

Maintenance Requirements: Minor repairs should be made when needed.

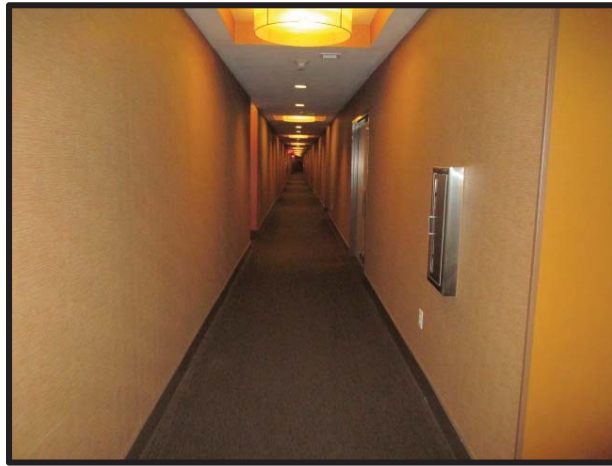
Carpet - Replace (Levels 25-33)

Age: Using 2010 as the average install date.

Current Condition: Carpet observed to be in good condition.

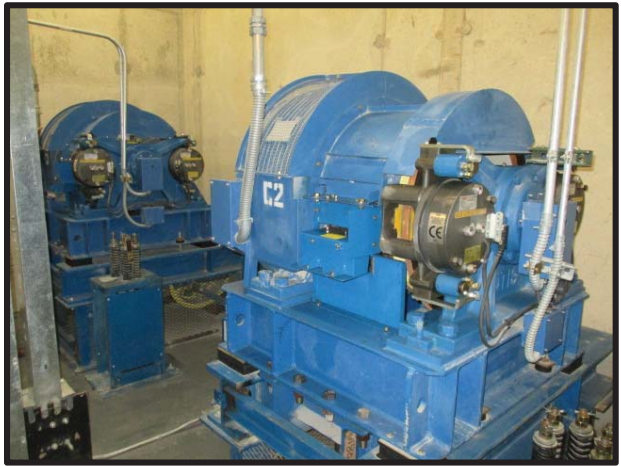
Age: Using 2010 as the average install date.

Current Condition: No reports of any unusual problems.

(3) passenger Traction Elevators. This project typically includes replacement/upgrade of controller(s), mechanical door components, push-button fixtures, code-required changes, etc. Elevator vendors typically recommend modernization cycles of approximately 25 years for continued smooth, safe operation, technology and code advances. In our experience, actual interval can be anywhere from 20-30 years or more depending on level of use, maintenance, availability of replacement parts, etc. When remaining useful life is within a year few years of 0, begin discussions with your vendor(s) to determine the most cost effective specifications and approach to a modernization project. Modernization should be anticipated and planned for, as lead time for required parts can be months-long if done on short notice. To minimize elevator downtime, schedule the project ahead of time and consult with elevator vendor for more information.

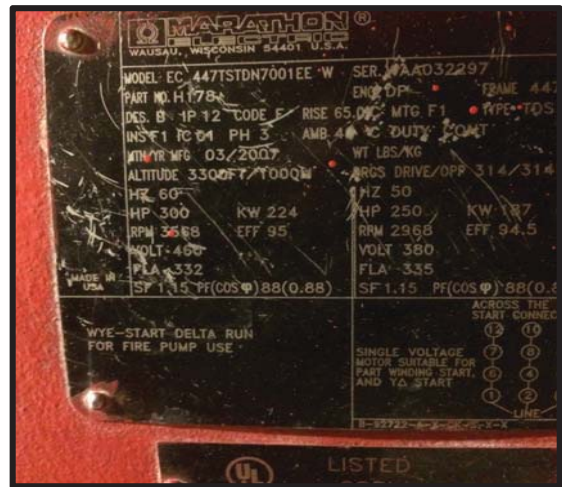
Fire Sprinkler Pump - Replace

Age: Using 2010 as the average install date.

Current Condition: No reported issues.

This system is considered a General Common Area Element and maintenance costs are shared between the Hotel and RROA based on a 73.52% (Hotel) and 26.48% (RROA) split. This pump should have a long useful life expectancy under normal circumstances. Over time, replacement parts may not be available and the Hotel/Association may need to replace the entire assembly prior to actual functional failure as a safety precaution.

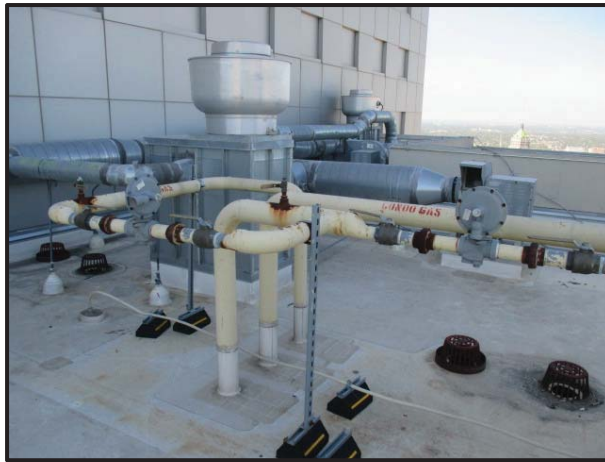
Membrane Roofing - Replace

Age: Using 2010 as the average install date.

Current Condition: Good condition.

Replacement cost is based on 26.48% of (21,000 SF X \$17.00/SF = \$375,000). The white material of TPO (Thermoplastic Olefin) provides energy savings in the form of high thermal emittance and solar reflection. Over time, with exposure to heat, ultraviolet light and whether this roof will deterioration and require replacement. Future replacement should be expected according to the schedule and cost listed above.

Maintenance Requirements: Repair as-needed from the Operating budget.

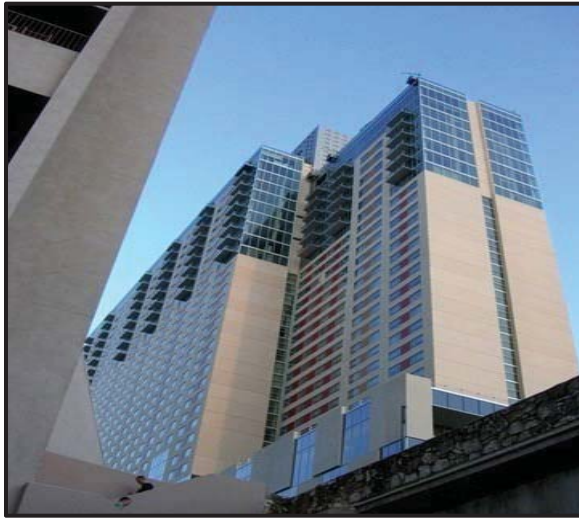
Age: Using 2010 as the average install date.

Current Condition: Building exterior surfaces observed to be new and in good condition.

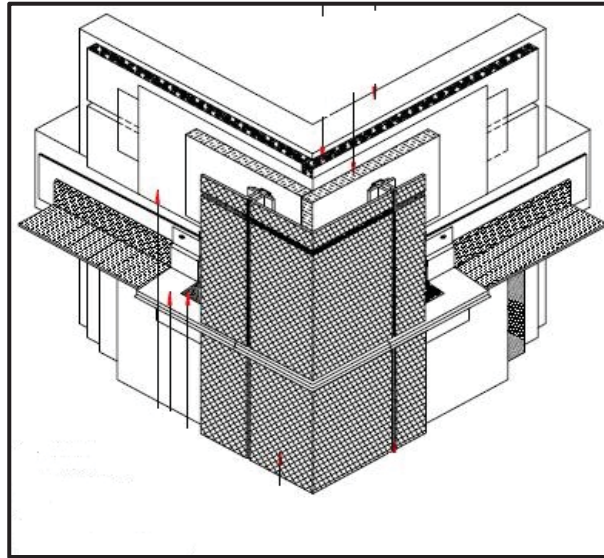
Age: Using 2010 as the average install date.

Current Condition: Building exterior surfaces observed to be new and in good condition.

Maintenance Requirements: Proper sealant/caulking is critical to preventing water intrusion and resulting damage to the building structure
