Sample Association

Regarding: FY2016 - Level I Capital Replacement Reserve Study

Sample Association is a 32-unit condominium project located in Flagstaff, Arizona. Construction began during 1986. 2016 budgeted reserve contributions are **\$494/Month or \$5,928/Year.** The association's major Reserve obligations include: four buildings, asphalt parking and common areas. In order to prepare for major capital expenditures associated with these assets, we **recommend** monthly reserve contributions to ***\$519/month** during 2016 with annual increases of 19.85% for 8 years followed by annual increases of 3% for the remaining years. In order to prepare for future reserve expenses associated with the parking asphalt and building roofs, we also recommend a one-time special assessment of \$25,000 during 2017.

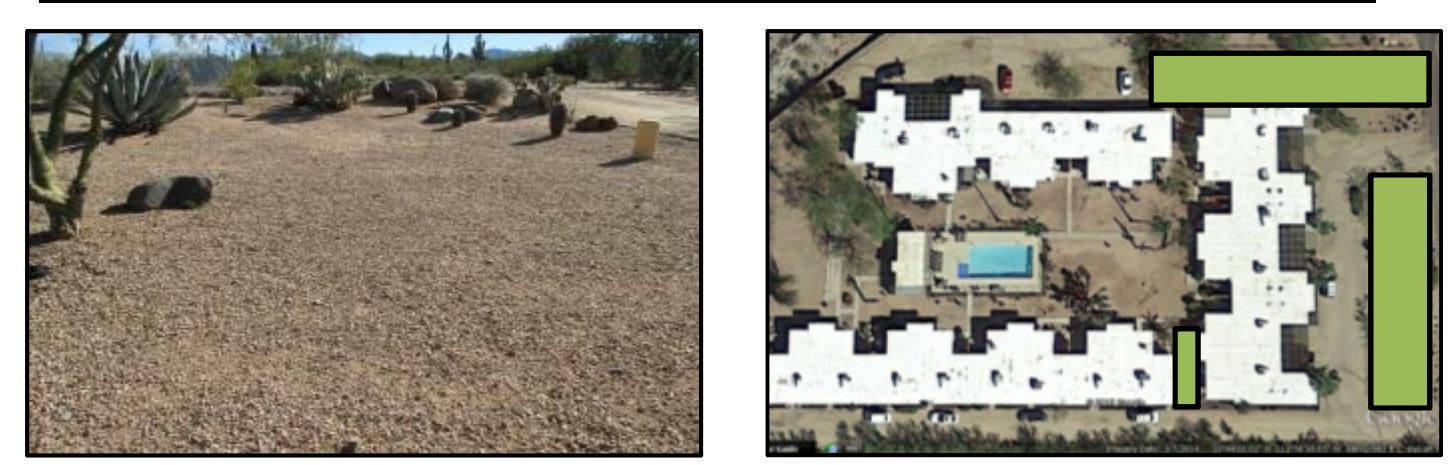
Over time, with rains, irrigation, silting, and being tread upon, granite is ground into smaller pieces and loses its fullness. To avoid exposed patches of dirt, we recommend periodic top dressing of the landscape rock. There is approximately 8,400 square feet of landscape rock located throughout the property. This component budgets to replenish 100% of the total square footage with ³/₄" rock at 2" deep which converts to approximately 70 tons of rock. Recommend replenishment at roughly the timing and costs above. See image above for areas currently covered with Landscape Granite. **Note:** We are only budgeting to replenish the areas highlighted in green above.

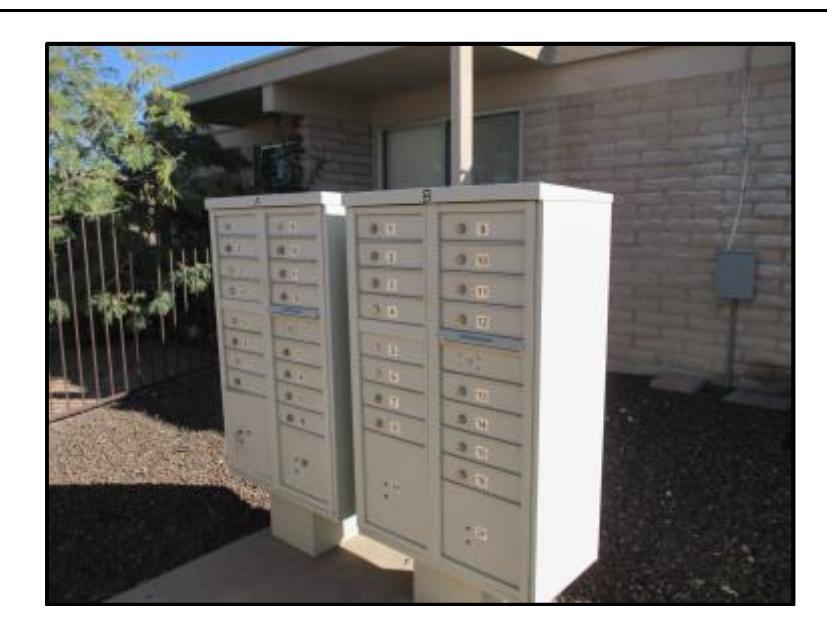
The association maintains (2) 16-unit cluster box units manufactured during 2004 by AF Florence Manufacturing company. These mailboxes are located on the southeastern corner of the property and are in good condition. Typical useful life expectancy for these types of mailboxes is between 20 and 25 years. The association should anticipate replacement at roughly the cost and time frame listed above.

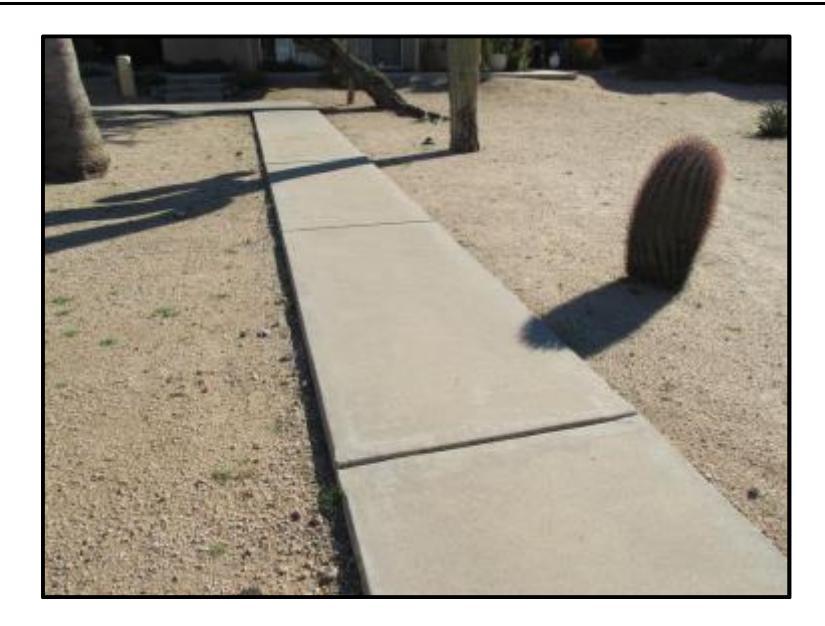
The association maintains approximately 1,370 square feet of concrete sidewalks and surface area throughout the property. These sidewalks are in overall good condition. Some signs of minor deterioration and cracking noted, however nothing major. Concrete surfaces typically have a useful life of up to 65 years although partial failures and deterioration is common. Weather conditions, installation methods and finishing techniques can result in premature deterioration such as cracks, chips and spalls. Various conditions like these result in the need to plan for periodic partial replacements over the next 30 years. We estimate approximately 10% of the concrete surfaces will require replacement on a 10 year cycle.

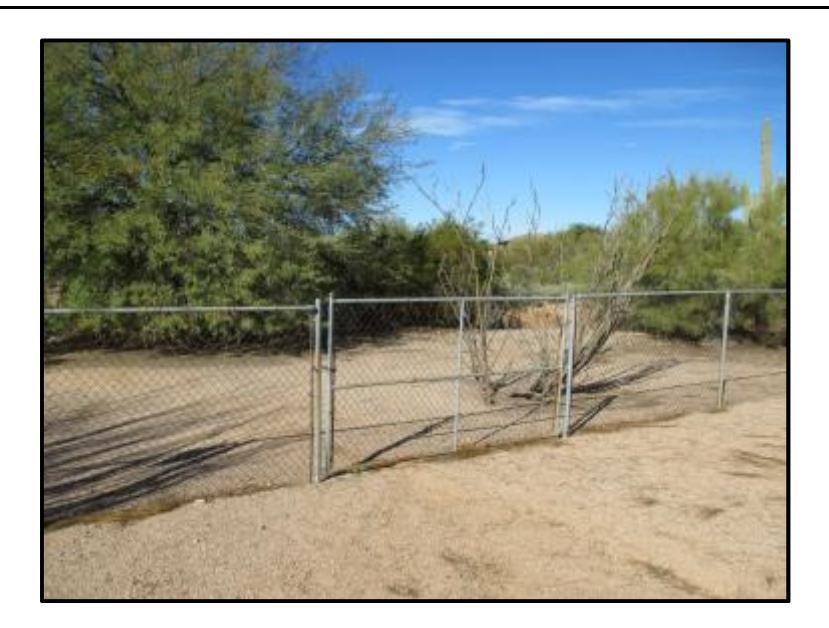
There is approximately 165 linear feet of 5' high chain link fencing located along the West perimeter of the property. This fence appears original from the 1970's. The association plans to replace this fencing with new wrought iron fencing to match the rest of the property fencing. Metal fencing has a long useful life, but is not maintenance free. Periodic maintenance should include periodic applications of protective paint finish. We anticipate a useful life of up to 30 years for this fence.

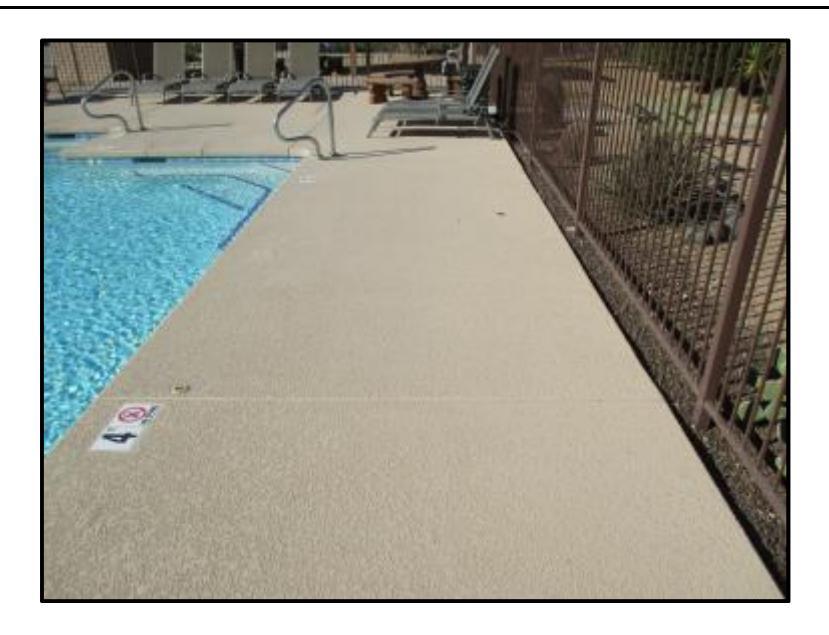
The pool deck was resurfaced during 2011. We suggest inspecting each year prior to annual operating budget process and factoring any local repair/replacement needs at that time. We recommend planning to resurface at the interval and pricing above based on our experience in similar communities.

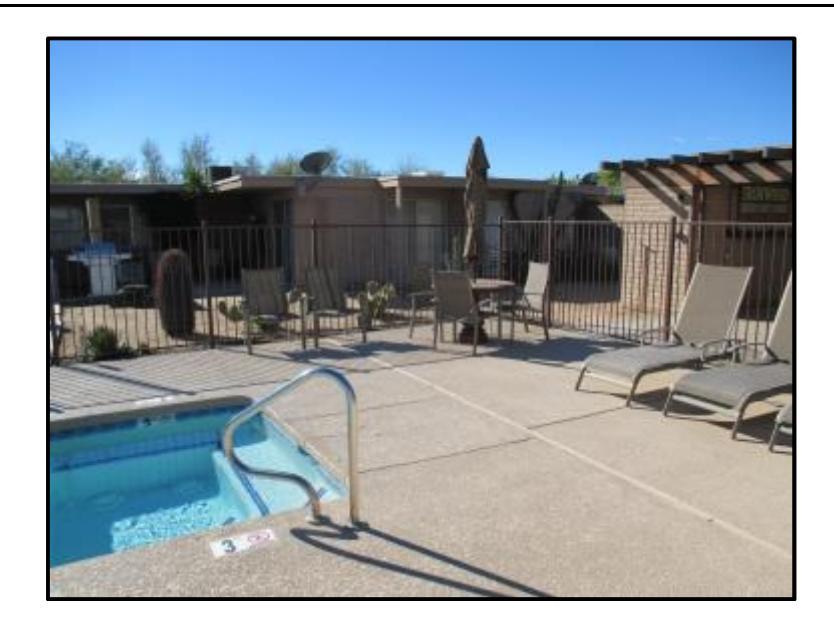
This pool deck was resurfaced during 2011 and appears to be in good condition. As routine maintenance, inspect regularly for any damage, repair as needed. Regular cycles of sealer/paint will help maintain appearance and maximize useful life. Remaining useful life reflects current conditions observed.

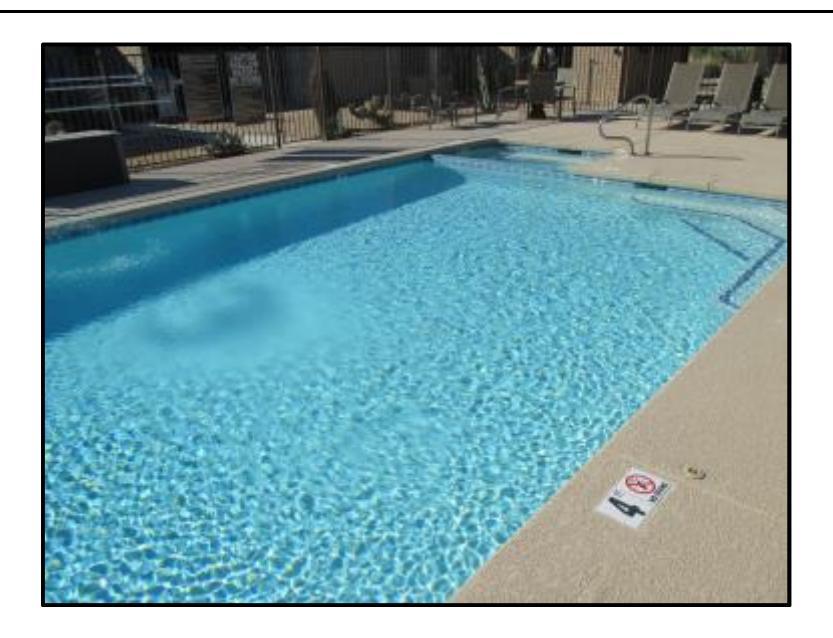
The pool & Spa were resurfaced with new plaster during 2011. Good condition observed. Continue to clean, maintain proper chemical balance to help extend intervals for resurface of plaster. Typical useful life cycle is between eight to twelve years depending on usage levels. Recommend planning replacement at roughly the cost and time frame listed above.

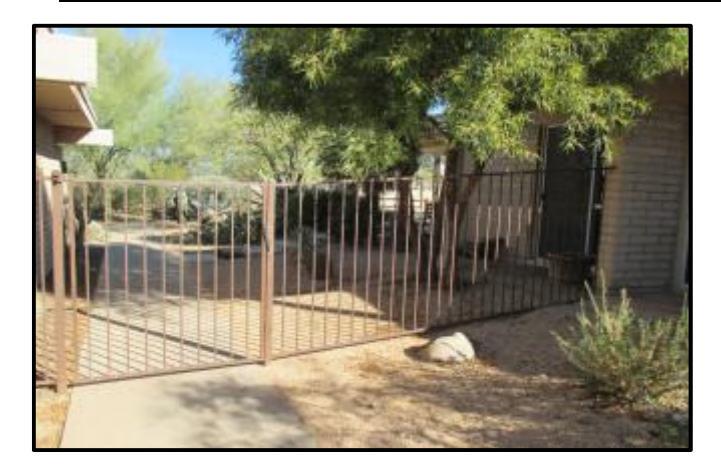
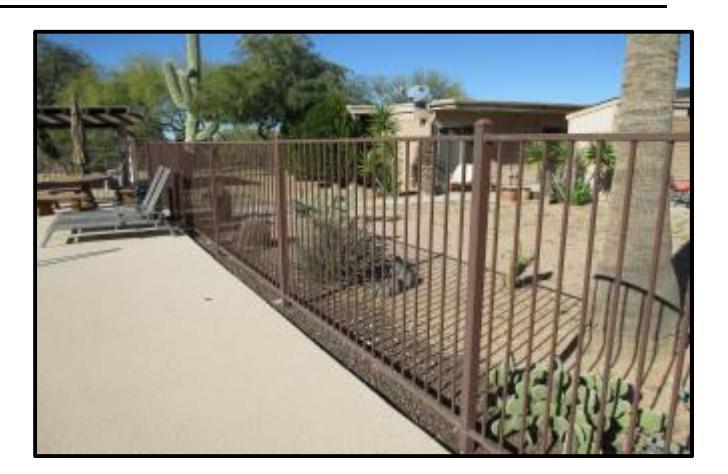
This component includes 190 linear feet of metal pool fence and 30 linear feet of fencing and gates located on the north and south side of the property. Repainting should be handled as an Operating expense; therefore no Reserve Funding is required. Metal components and structural connections are prone to rusting if not thoroughly maintained.

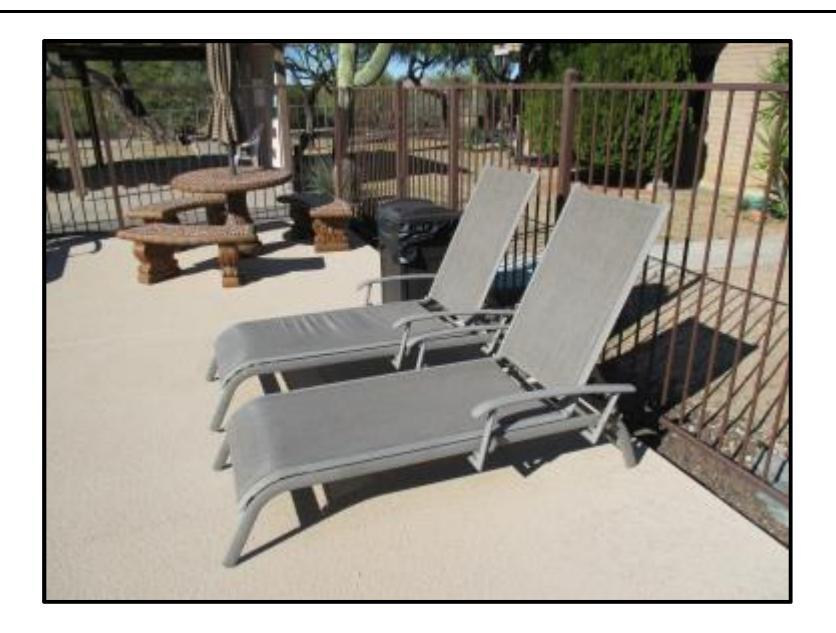
Furniture installed during 2011. This component includes (6) chaise lounges, (2) trash receptacles, (5) table chairs, and (2) fabric umbrellas. We are not funding to replace the (3) concrete tables as these should last the lifetime of the property. See the table below for unit costs and quantities.

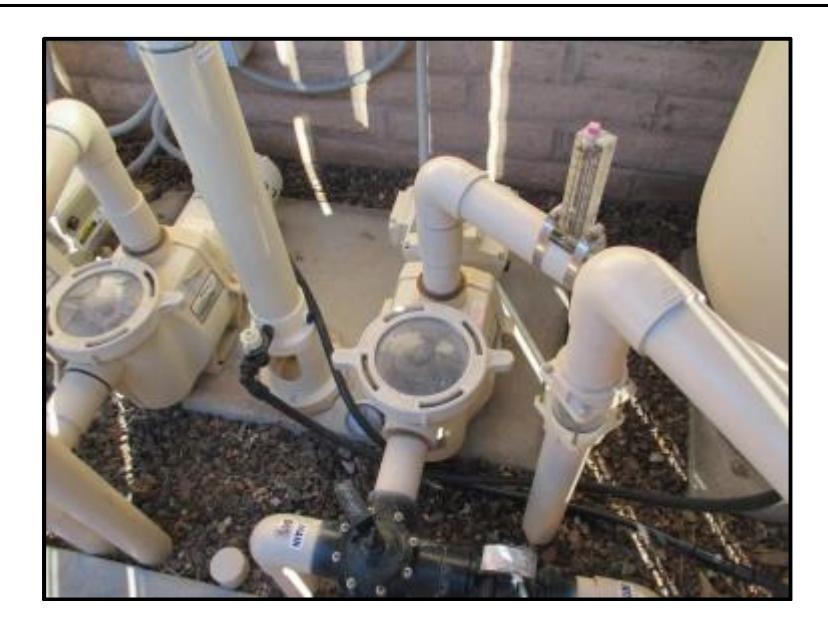
This spa pump was installed during 2007. Observed to be functional and in decent condition. Manufacturer: WhisperFlo, Model Number: WFE-8 208-230V, Horse Power: 2, Serial Number: 03262540701530. As routine maintenance, inspect regularly and repair out of the Operating budget.

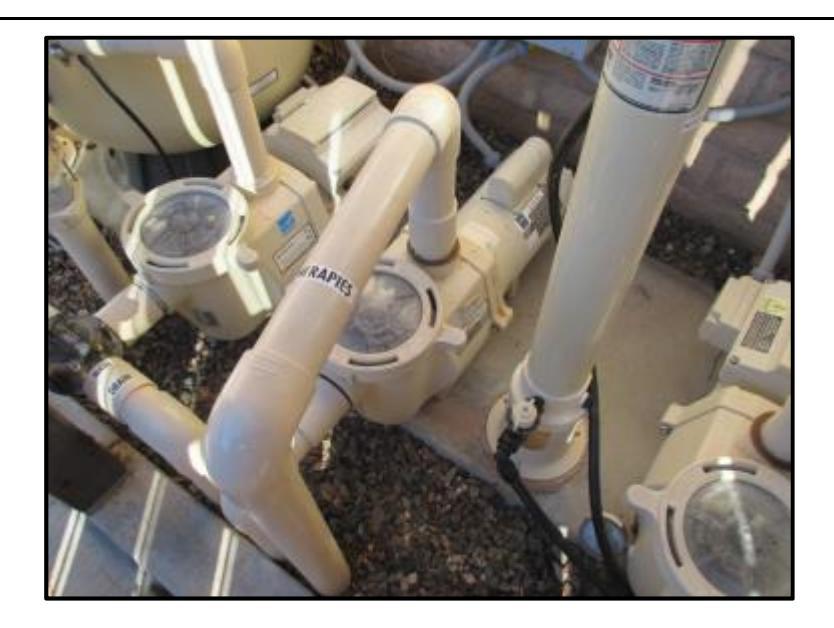
This pool pump was installed during 2010. Observed to be functional and in good condition. Manufacturer: IntelliFlo, Model Number: VS0350 Horse Power: 3, Serial Number: 0332118100014P. As routine maintenance, inspect regularly and repair out of the Operating budget.

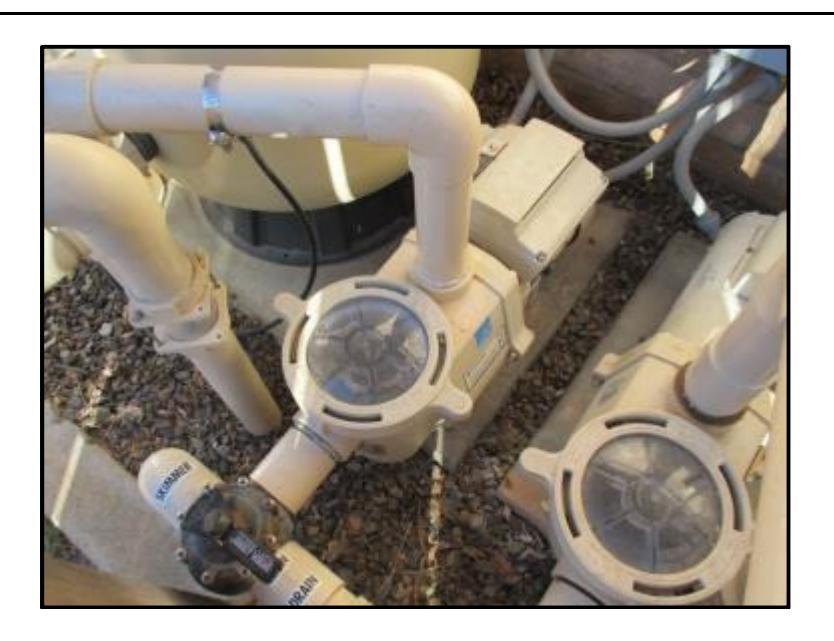
This pool pump was installed during 2014. Observed to be functional and in good condition. Manufacturer: IntelliFlo, Model Number: VS3050 Horse Power: 3, Serial Number: 033209110207A. As routine maintenance, inspect regularly and repair out of the Operating budget.

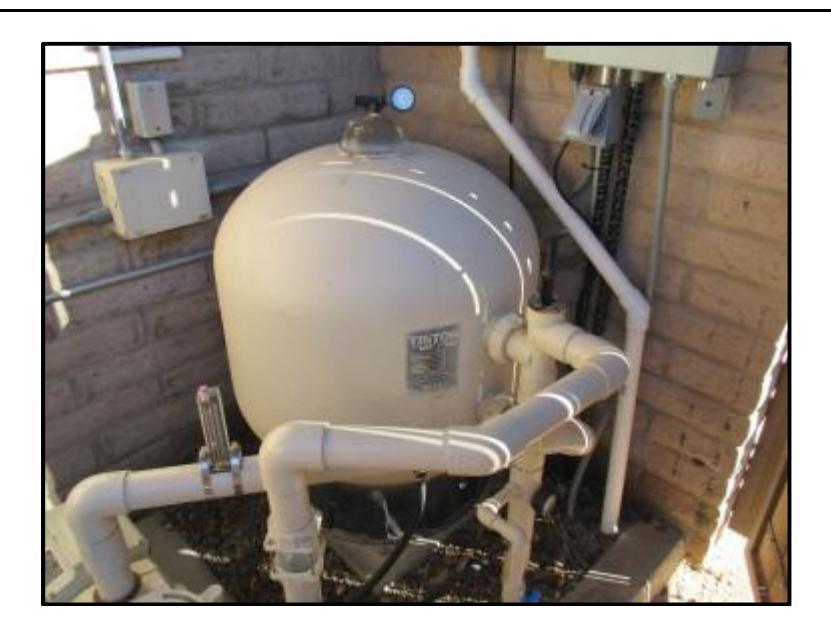
This Triton TR-100 was installed during 1995. No signs of leaking or damage noted, however based on age, replacement should be anticipated at some point in the near future. Model: TR-100, Serial Number: 47795.

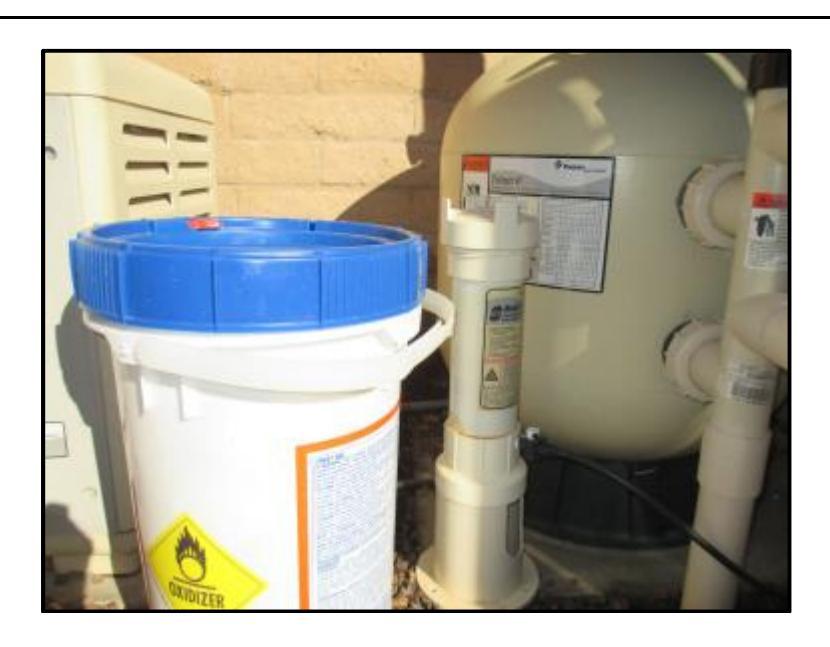
This Triton TR-60 was installed during 2011. No signs of leaking or damage noted. Good condition observed. Inspect regularly and repair out of the Operating budget as needed. Model: TR-60, Serial Number: 0101068110056L.

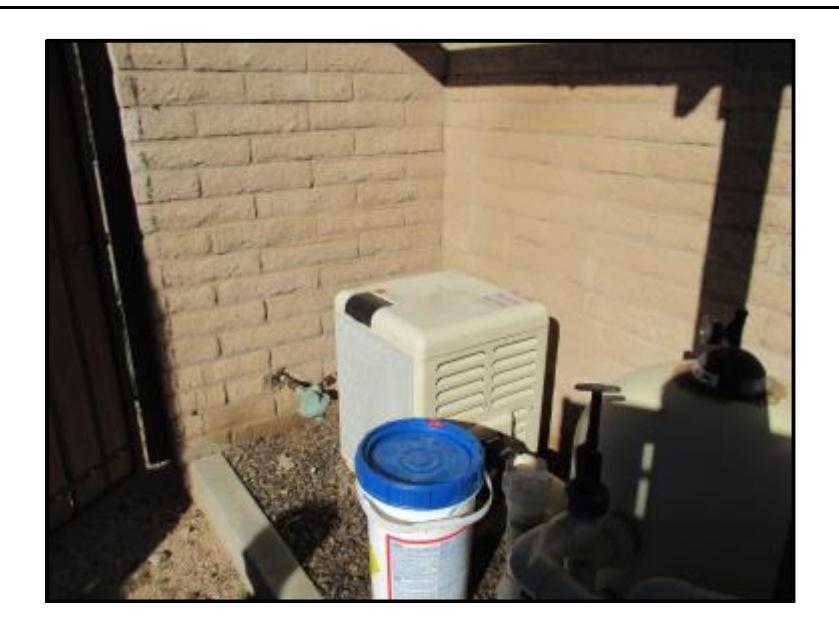
This heater was installed during 2011 for approximately \$1,760. No observed or reported damage. Recommend professional inspections, maintenance and repair to maximize useful life cycles.

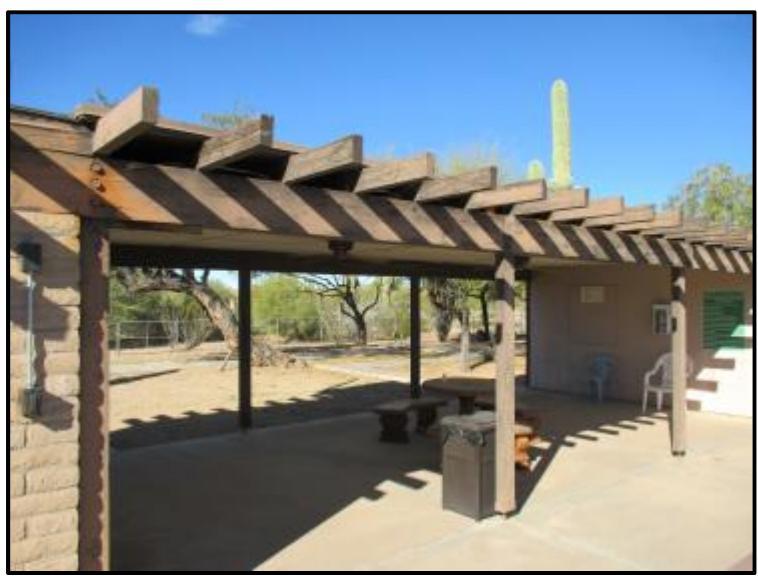
The wood beams exhibit signs of dry rot and deterioration. The association plans to restore this structure during 2015. This project will include removal of the deteriorated wood beams, installation of new fascia boards, and re-coating of all exterior wood beams.

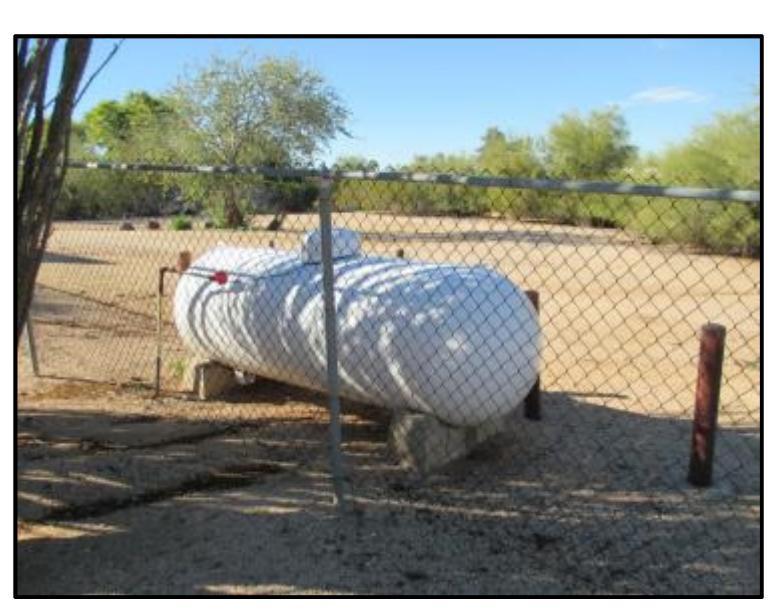
This tank was installed during 2011 for approximately \$1,250. No reported leaks or damage observed.

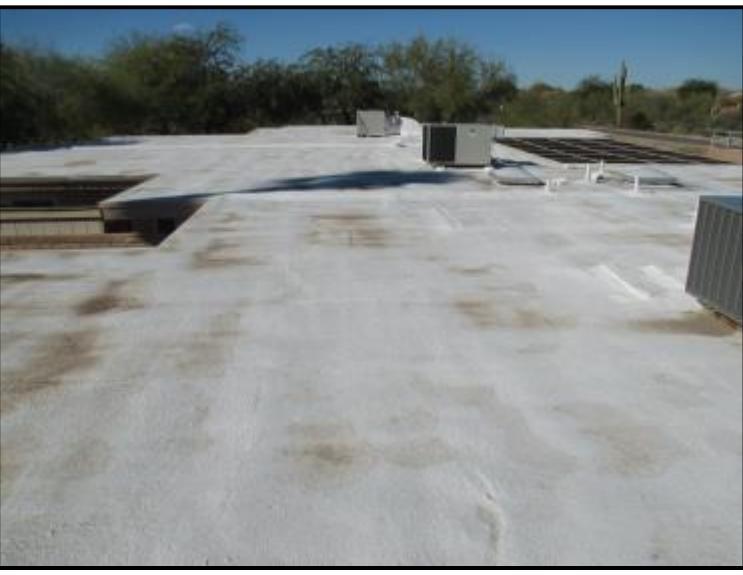
The North and South foam roofs were recoated during 2011. During our inspection, we noted signs of ponding and some areas of minor damage. Recommend inspecting regularly and removing and debris. If water sits on the surface for more than 48 hours, it is called ponding. Ponding breaks down the acrylic coating and reduces the service life of your roof. Per **Sprayfoam Southwest**, foam roofs should be recoated 10 years after installation and every 5 years thereafter. If properly maintained, these roofs will last the lifetime of the community. Recommend annual inspections and repairs when needed.

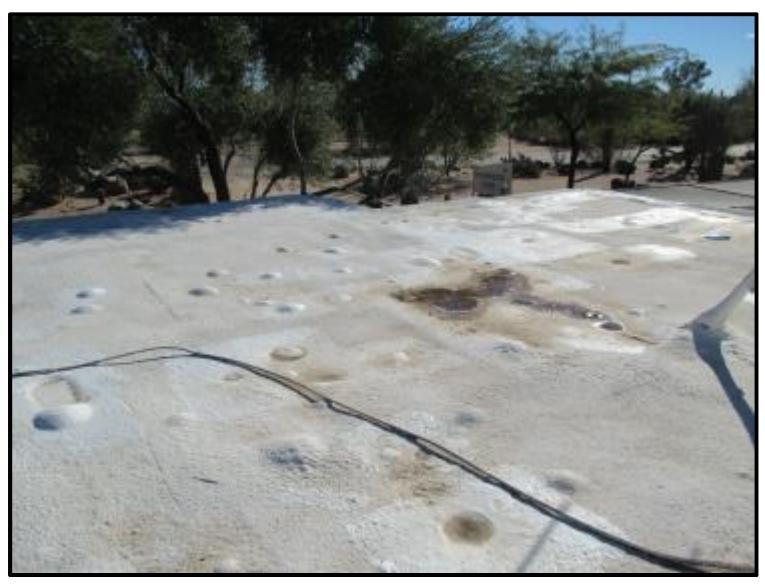
The East foam roof was replaced during 2011. During our inspection, we noted signs of ponding and several "Blisters". When moisture gets trapped while foam is being applied, it can cause high spots, or "blisters" in the foam. If the blister is sound enough structurally and is not broken, it is a cosmetic issue, unless it is creating severe ponding. If it is creating severe ponding, the acrylic can lift or separate from the foam, which will require maintenance more often than the rest of the roof. If the blister is broken, it can cause seepage into and below it. If "Blisters" get broken, they need to be cut it out and foam and acrylic coating need to be re-applied. Recommend inspecting regularly and removing and debris. Per **Sprayfoam Southwest**, foam roofs should be recoated 10 years after installation and every 5 years thereafter. If properly maintained, these roofs will last the lifetime of the community. Recommend annual inspections and repairs when needed. The remaining useful life of 6 years represents the 10 year initial warranty.

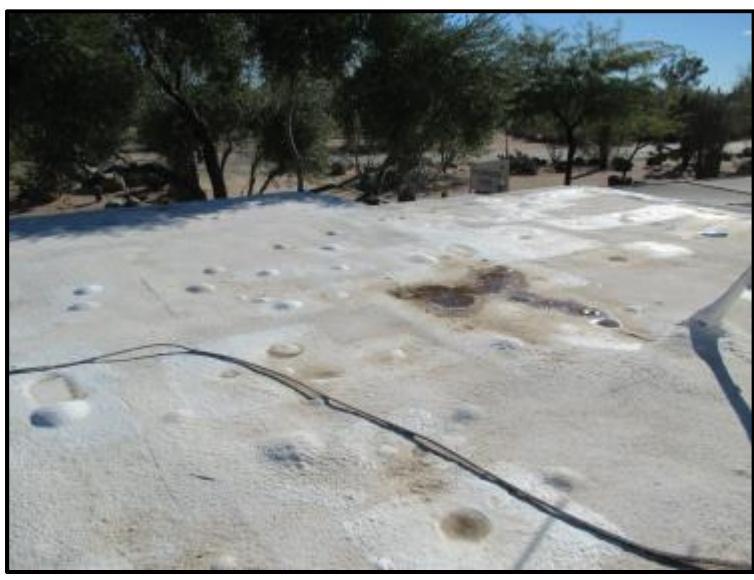
This line item provides an allowance for periodic repairs and replacements to the foam roofs. During our site inspection, we noted several "Blisters" and areas of ponding. We recommend a professional roofing inspection to assess the current condition of the roofs and determine needed repairs.

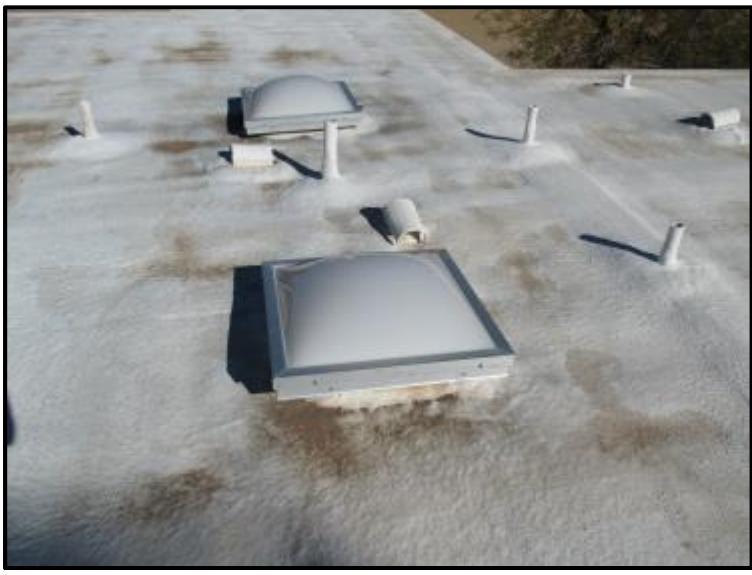
There are approximately (16) skylights. These skylights were installed during 2011. No major damage or deterioration noted. Recommend annual inspections in conjunction with the roofing systems. Future replacement should be anticipated at roughly the cost and time frame listed above.

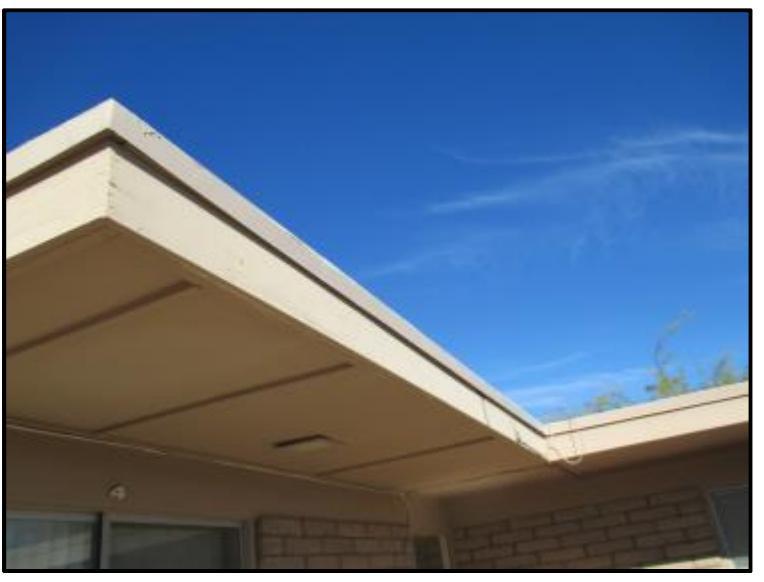
Wood trim comprises one of the exterior finish materials of the buildings. Periodic application of a protective finish of paint or stain is an essential maintenance activity to maintain the physical appearance and integrity of the buildings. The Board plans to repaint the wood trim in 2015. The useful life of protective paint finishes in Arizona is four to five years. We recommend that Sample Property budget for replacement of rotted or damaged wood trim in coordination with each paint finish application see component "Wood Trim – Replace/Repair".

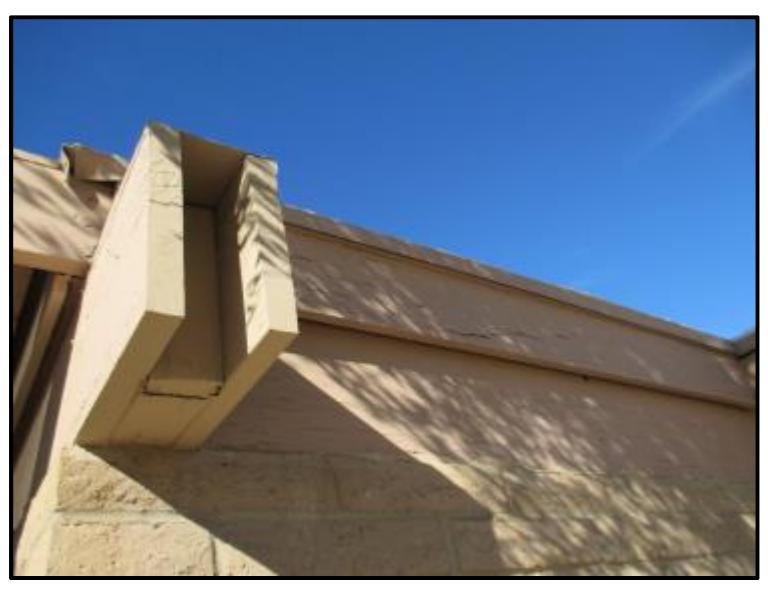
Wood trim comprises one of the exterior finish materials of the buildings. We recommend that Sample Property budget for replacement of rotted or damaged wood trim in coordination with each paint finish application. This component provides an allowance for periodic repairs and replacements to the wood trim.
